THE FEBEX IN SITU TEST: AN 18-YEAR LONG SIMULATION OF AN ENGINEERED BARRIER

María Victoria Villar
CIEMAT, Madrid

DOCTORAL SCHOOL
EURAD WP GAS & WP HITEC
28 August – 1 September 2023, Liege (BE)

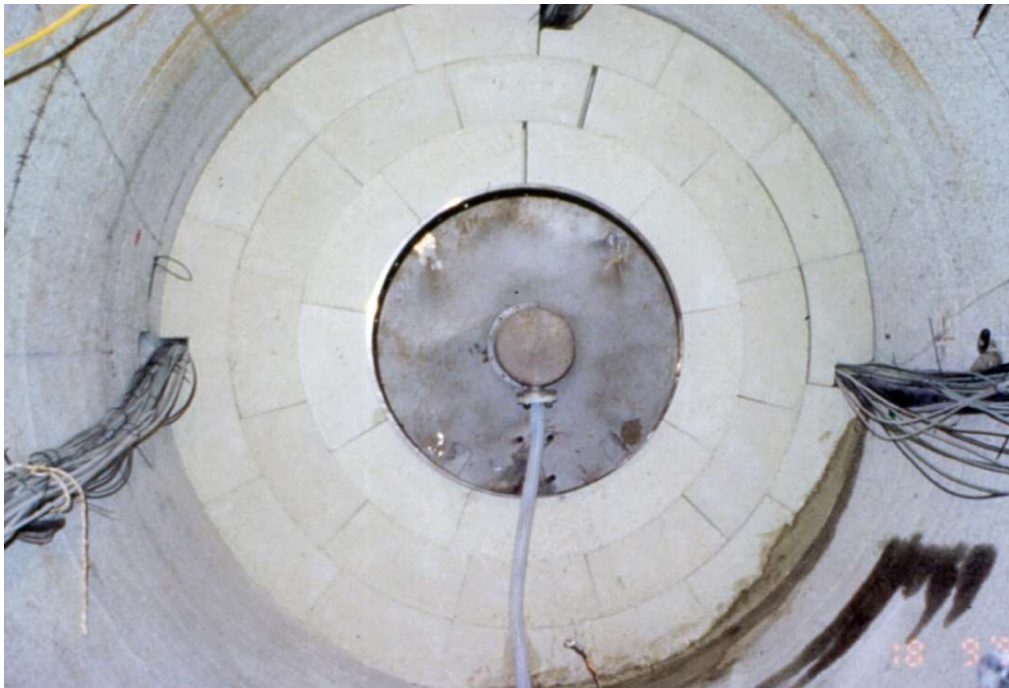
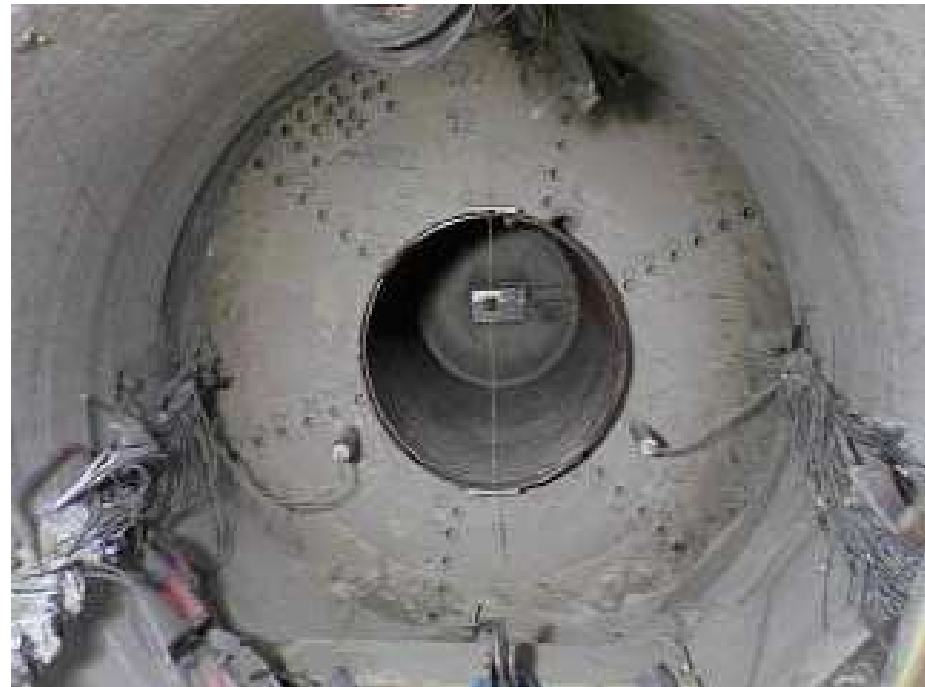
HM coupling: changes in density

Filling of gaps: decrease of the density of bentonite

Initial block dry density: 1.70 g/cm^3

After 5 years: $\rho_d = 1.60 \text{ g/cm}^3$

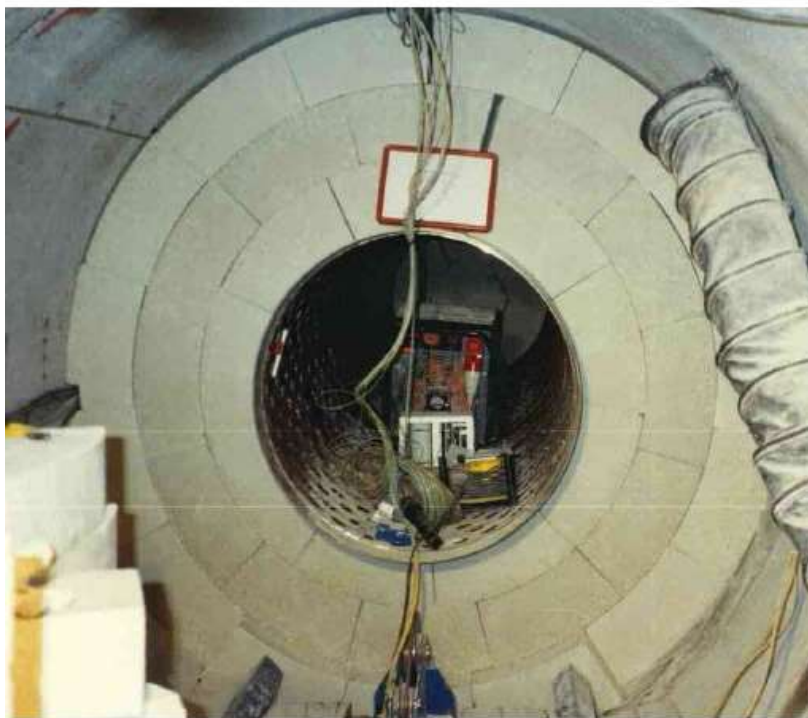
The joints between blocks had dissapeared, as it was already observed in 2002

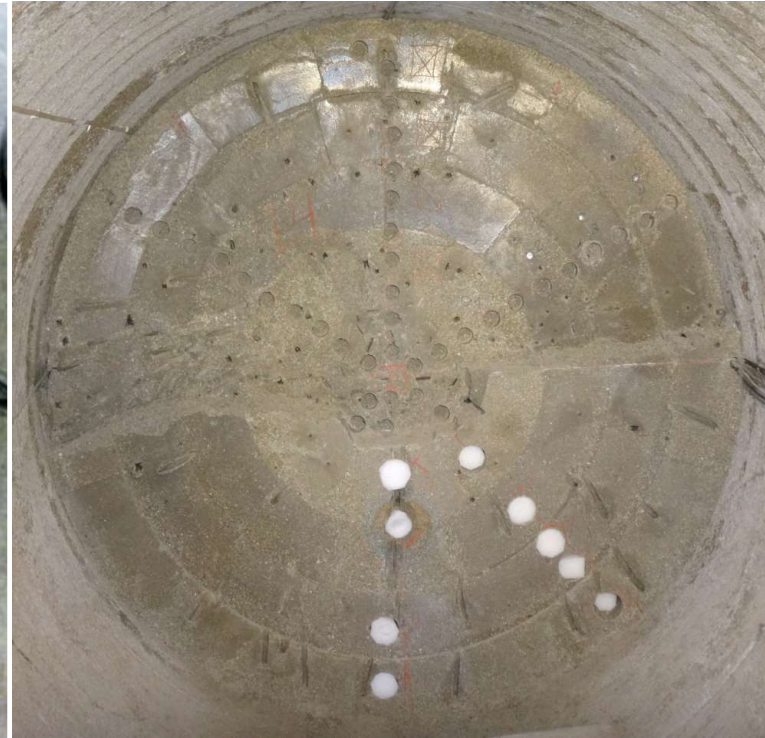
FINAL DISMANTLING: GAP SEALING

There were no gaps in the barrier, as it was already observed in 2002

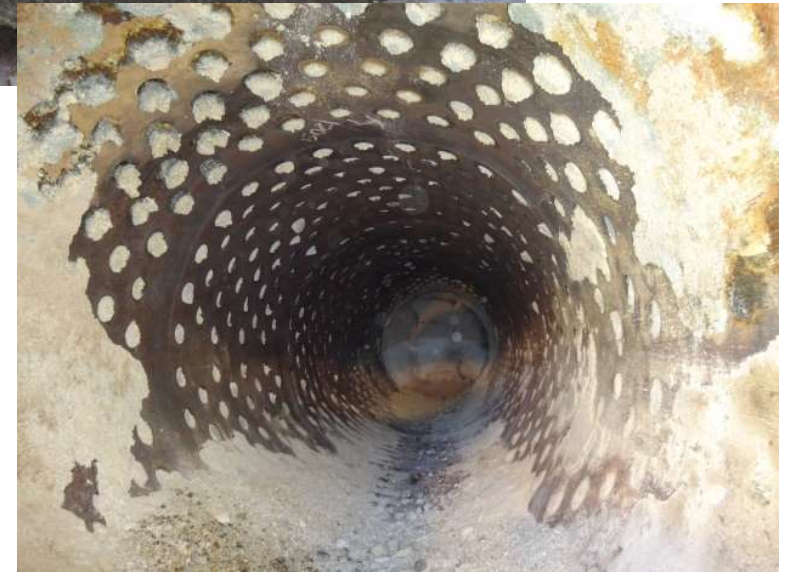
The contact between adjacent vertical sections and between granite and bentonite was tight

The bentonite intruded through the liner holes

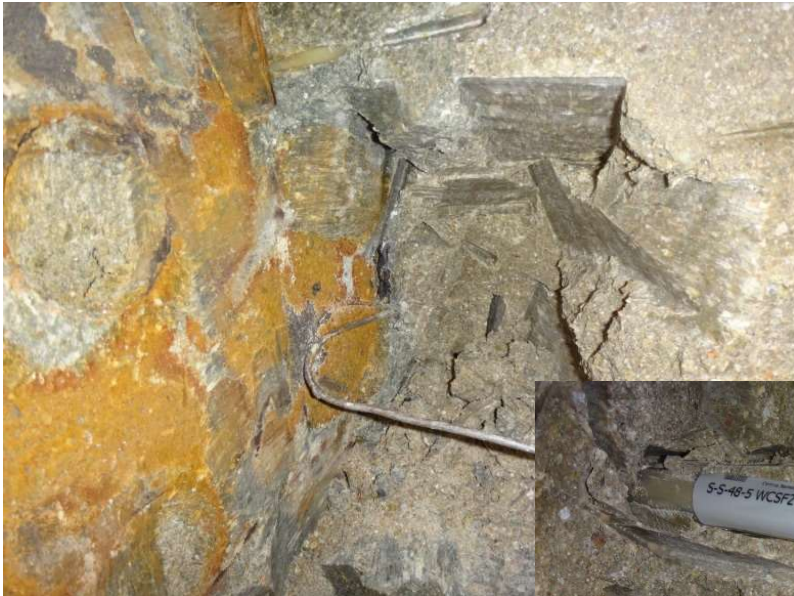
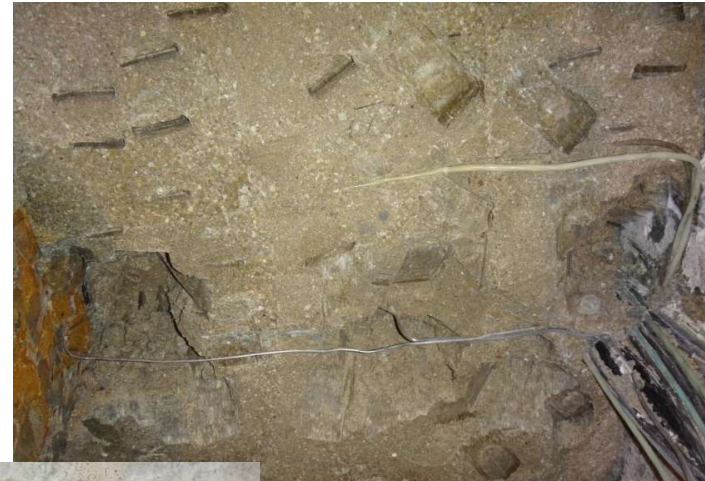
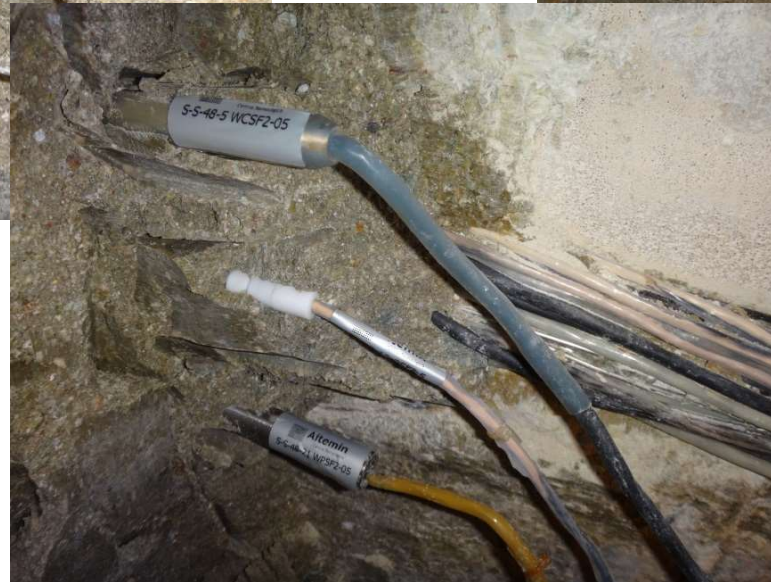
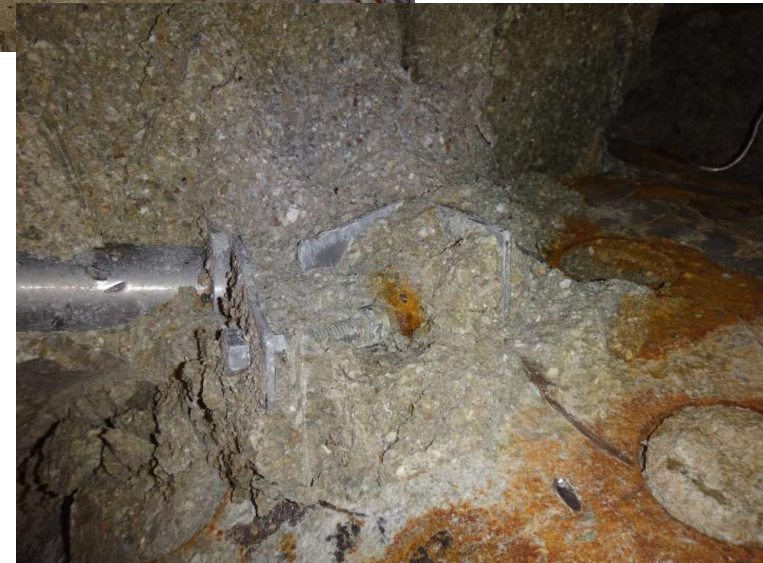
Sensor and other metallic elements: corrosion, stains

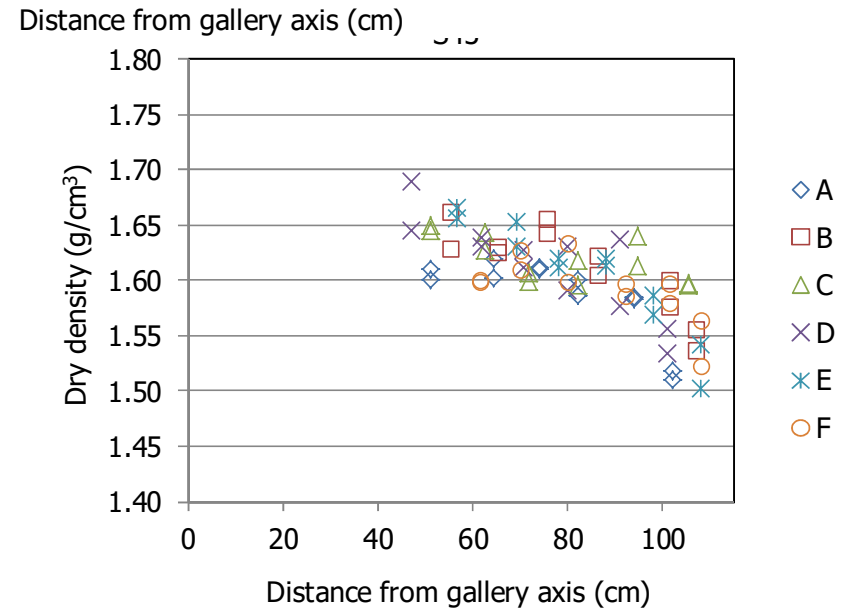
SECTION 43
 18 years hydration under
 thermal gradient
 (85-35°C)
 47 days cooling

Average
 w : 27.2%
 ρ_d : 1.59 g/cm³
 S_r : 105%
